**Annual Inspection carried out at
Wealstone Lane, Upton
on 07th September 2020
on behalf of Upton-by-Chester PC**

**Alan Dymond, RPII Annual Inspector
(No. 1056A)**

Name of Play Area: Wealstone Lane

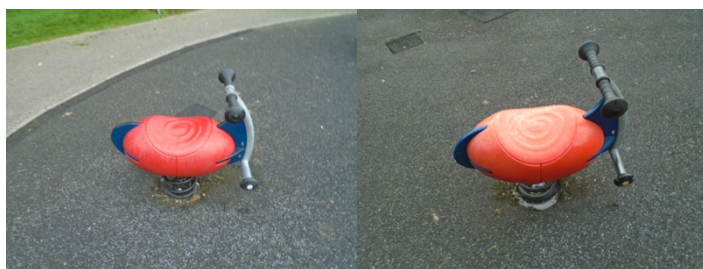
(1) Spring Rockers x 2

The items meet the requirements of BSEN 1176 where this may be tested on site without dismantling or destruction.

1 x handgrip is loose – low risk - secure.

Indentation marks evident – low risk - repair.

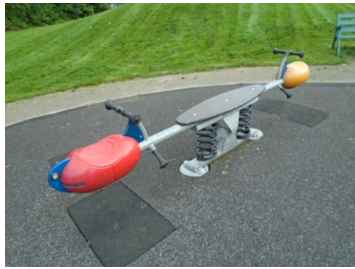
(2) Spring Seesaw

The item meets the requirements of BSEN 1176 where this may be tested on site without dismantling or destruction.

Hand grip damaged – *low risk* - monitor.

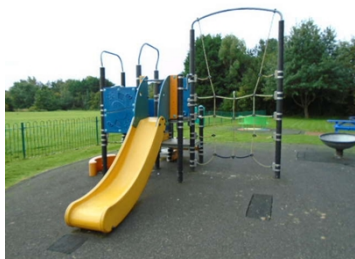
(3) Toddler Multi-Play Unit

The item fails to meet the requirements of BSEN 1176 in the following respect:

Finger entrapment evident – top of support post – *low risk* - missing cap – replace.

Rope damaged on climbing net – *low risk* – missing blue climbing platform – monitor.

Rope wear evident/plastic covering damaged – *low risk* - tape up.

Surface base collapse evident – *low risk* - repair.

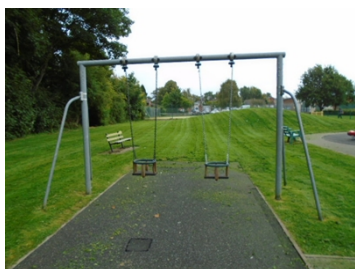
(4) Swing, 2.0m High, 1 Bay/2 Seat (Cradle)

Kompan The item meets the requirements of BSEN 1176 where this may be tested on site without dismantling or destruction.

The item is in good condition and no work is required at this time.

Base collapse evident – *low risk* - monitor and repair if it worsens.

Damaged in areas – *low risk* - repair.

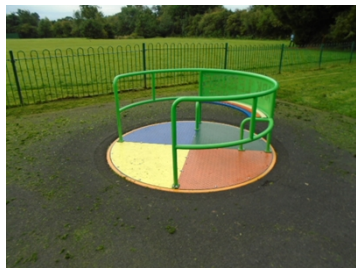
(5) Roundabout

Park Leisure The item meets the requirements of BSEN 1176 where this may be tested on site without dismantling or destruction.

Fixing bolts missing on platform – *low risk* - replace.

Item not rotating correctly – possible bearing wear/damage - *low risk* - internal investigation required.

Seam separation evident – *low risk* - repairs required.

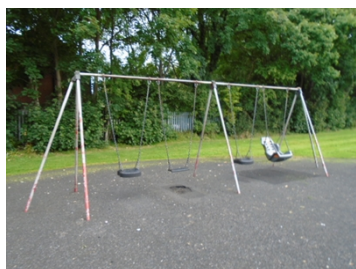
(6) Swing 2.4m High, 2 Bay/4 Seat (Flat/Special Seat)

Wicksteed The item fails to meet the requirements of BSEN 1176 in the following respect:

Chain link opening greater than 8.6mm – *low risk* - monitor.

Surface damage evident – *low risk* - repair.

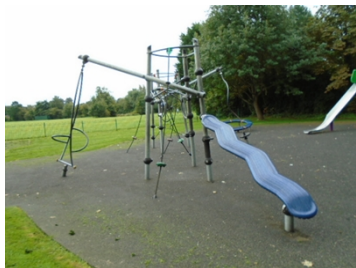
(7) Galaxy Junior Multi-Play Unit

The item meets the requirements of BSEN 1176 where this may be tested on site without dismantling or destruction.

Item not rotating correctly - possible bearing wear/damage – *low risk* - internal investigation required.

Surface cracks evident – *low risk* - repair.

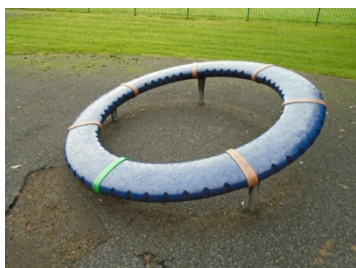
(8) Supernova

The item meets the requirements of BSEN 1176 where this may be tested on site without dismantling or destruction.

The item is in good condition and no work is required at this time.

Surface damage evident – *low risk* - repair.

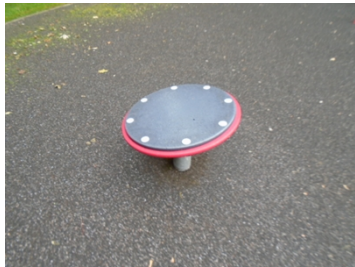
(9) Rotating Disc

The item meets the requirements of BSEN 1176 where this may be tested on site without dismantling or destruction.

The item is in good condition and no work is required at this time.

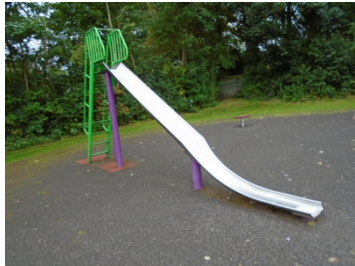
(10) Slide

The item meets the requirements of BSEN 1176 where this may be tested on site without dismantling or destruction.

Chute damaged/pitted in places – low risk - monitor.

Base collapse adjacent to chute – low risk - monitor.

Moss growth evident under slide chute – low risk - remove and clean.

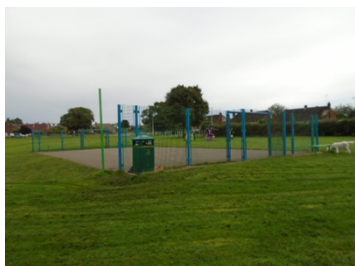
(11) Goal Ends x 2

The item fails to meet the requirements of EN 15312 in the following respect:

No EN 15312 warning signs.

Fixing bolts missing on fence – finger entrapment evident – *low risk* - replace.

Protruding fixing bolts evident – *low risk* - crop off and file down to nut level.

Rust evident on mesh fencing – rub down, treat and re-paint.

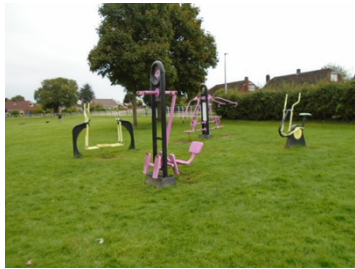
(12) Outdoor Gym Equipment

The item fails to meet the requirements of EN 16630 in the following respect:

Chest Press - Bolt missing creating a finger entrapment – *low risk* replace.

One Leg Press Seat missing – *low risk* - replace. The remaining seat is loose on its fixing point – *low risk* – secure.

Rust/corrosion evident – *low risk* - rub down, treat and re-paint affected areas.

Rubber handgrips missing – *low risk* - replace.

Several items are loose in the ground – *low risk* - secure.

An EN 16630 sign is required for the gym area stating/with the following information:

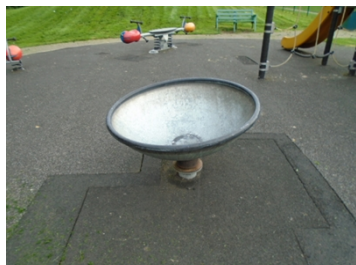
(13) Dish

The item meets the requirements of BSEN 1176 where this may be tested on site without dismantling or destruction.

The item is in good condition and no work is required at this time.

Seam separation evident – *low risk* - fill in.

Surface damage evident – *low risk* - repair.
